Nelson City Council

Tahunanui Area Liquefaction
Assessment

Report prepared by:
Tonkin & Taylor Ltd

November 2013

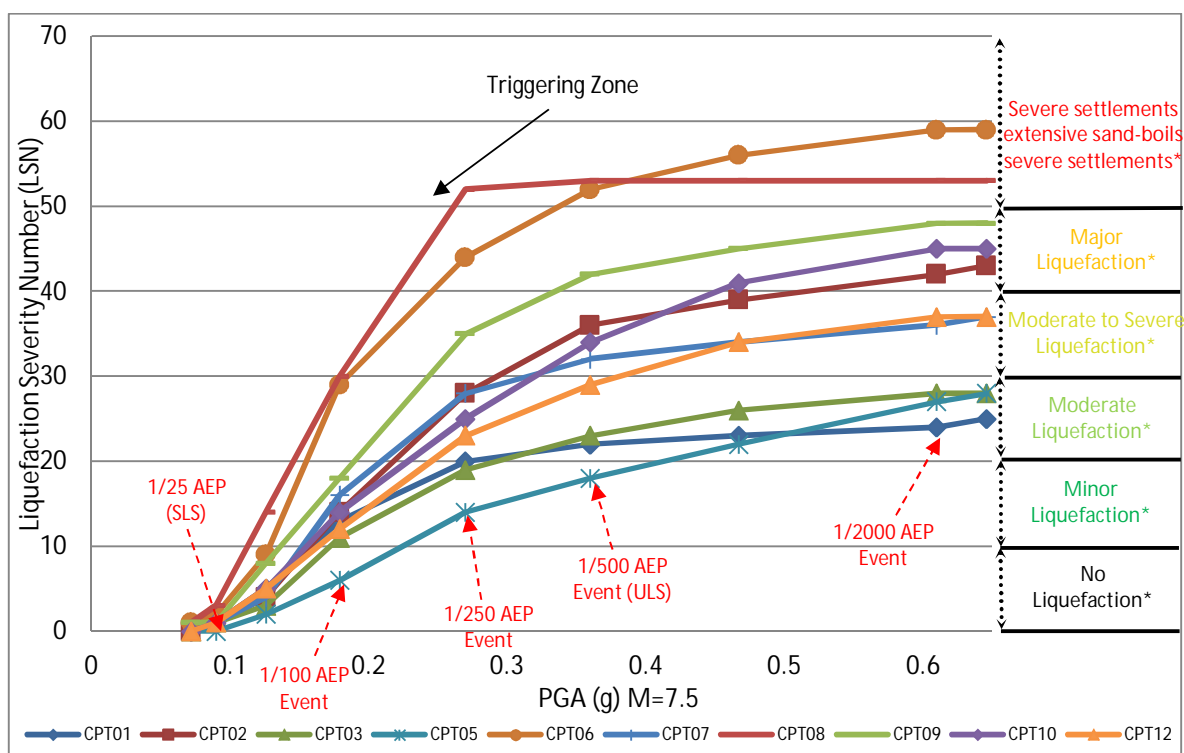
Figure 1 –LSN versus PGA at Tahunanui

Analysis has been undertaken to assess the trigger for liquefaction of susceptible soils in the Study Area by applying the cone penetration test (CPT) results. Published methods for liquefaction assessment (Idriss & Boulanger, 2008) and settlement (Zhang, Robertson, & Brachman, 2002) were applied. Figure 1 presents the assessed LSN for each CPT test for various return periods of earthquake shaking. More intense earthquake shaking (higher return period) will trigger liquefaction of more dense soils and thus result in a greater LSN.

* Predominant performance as per Table 5.

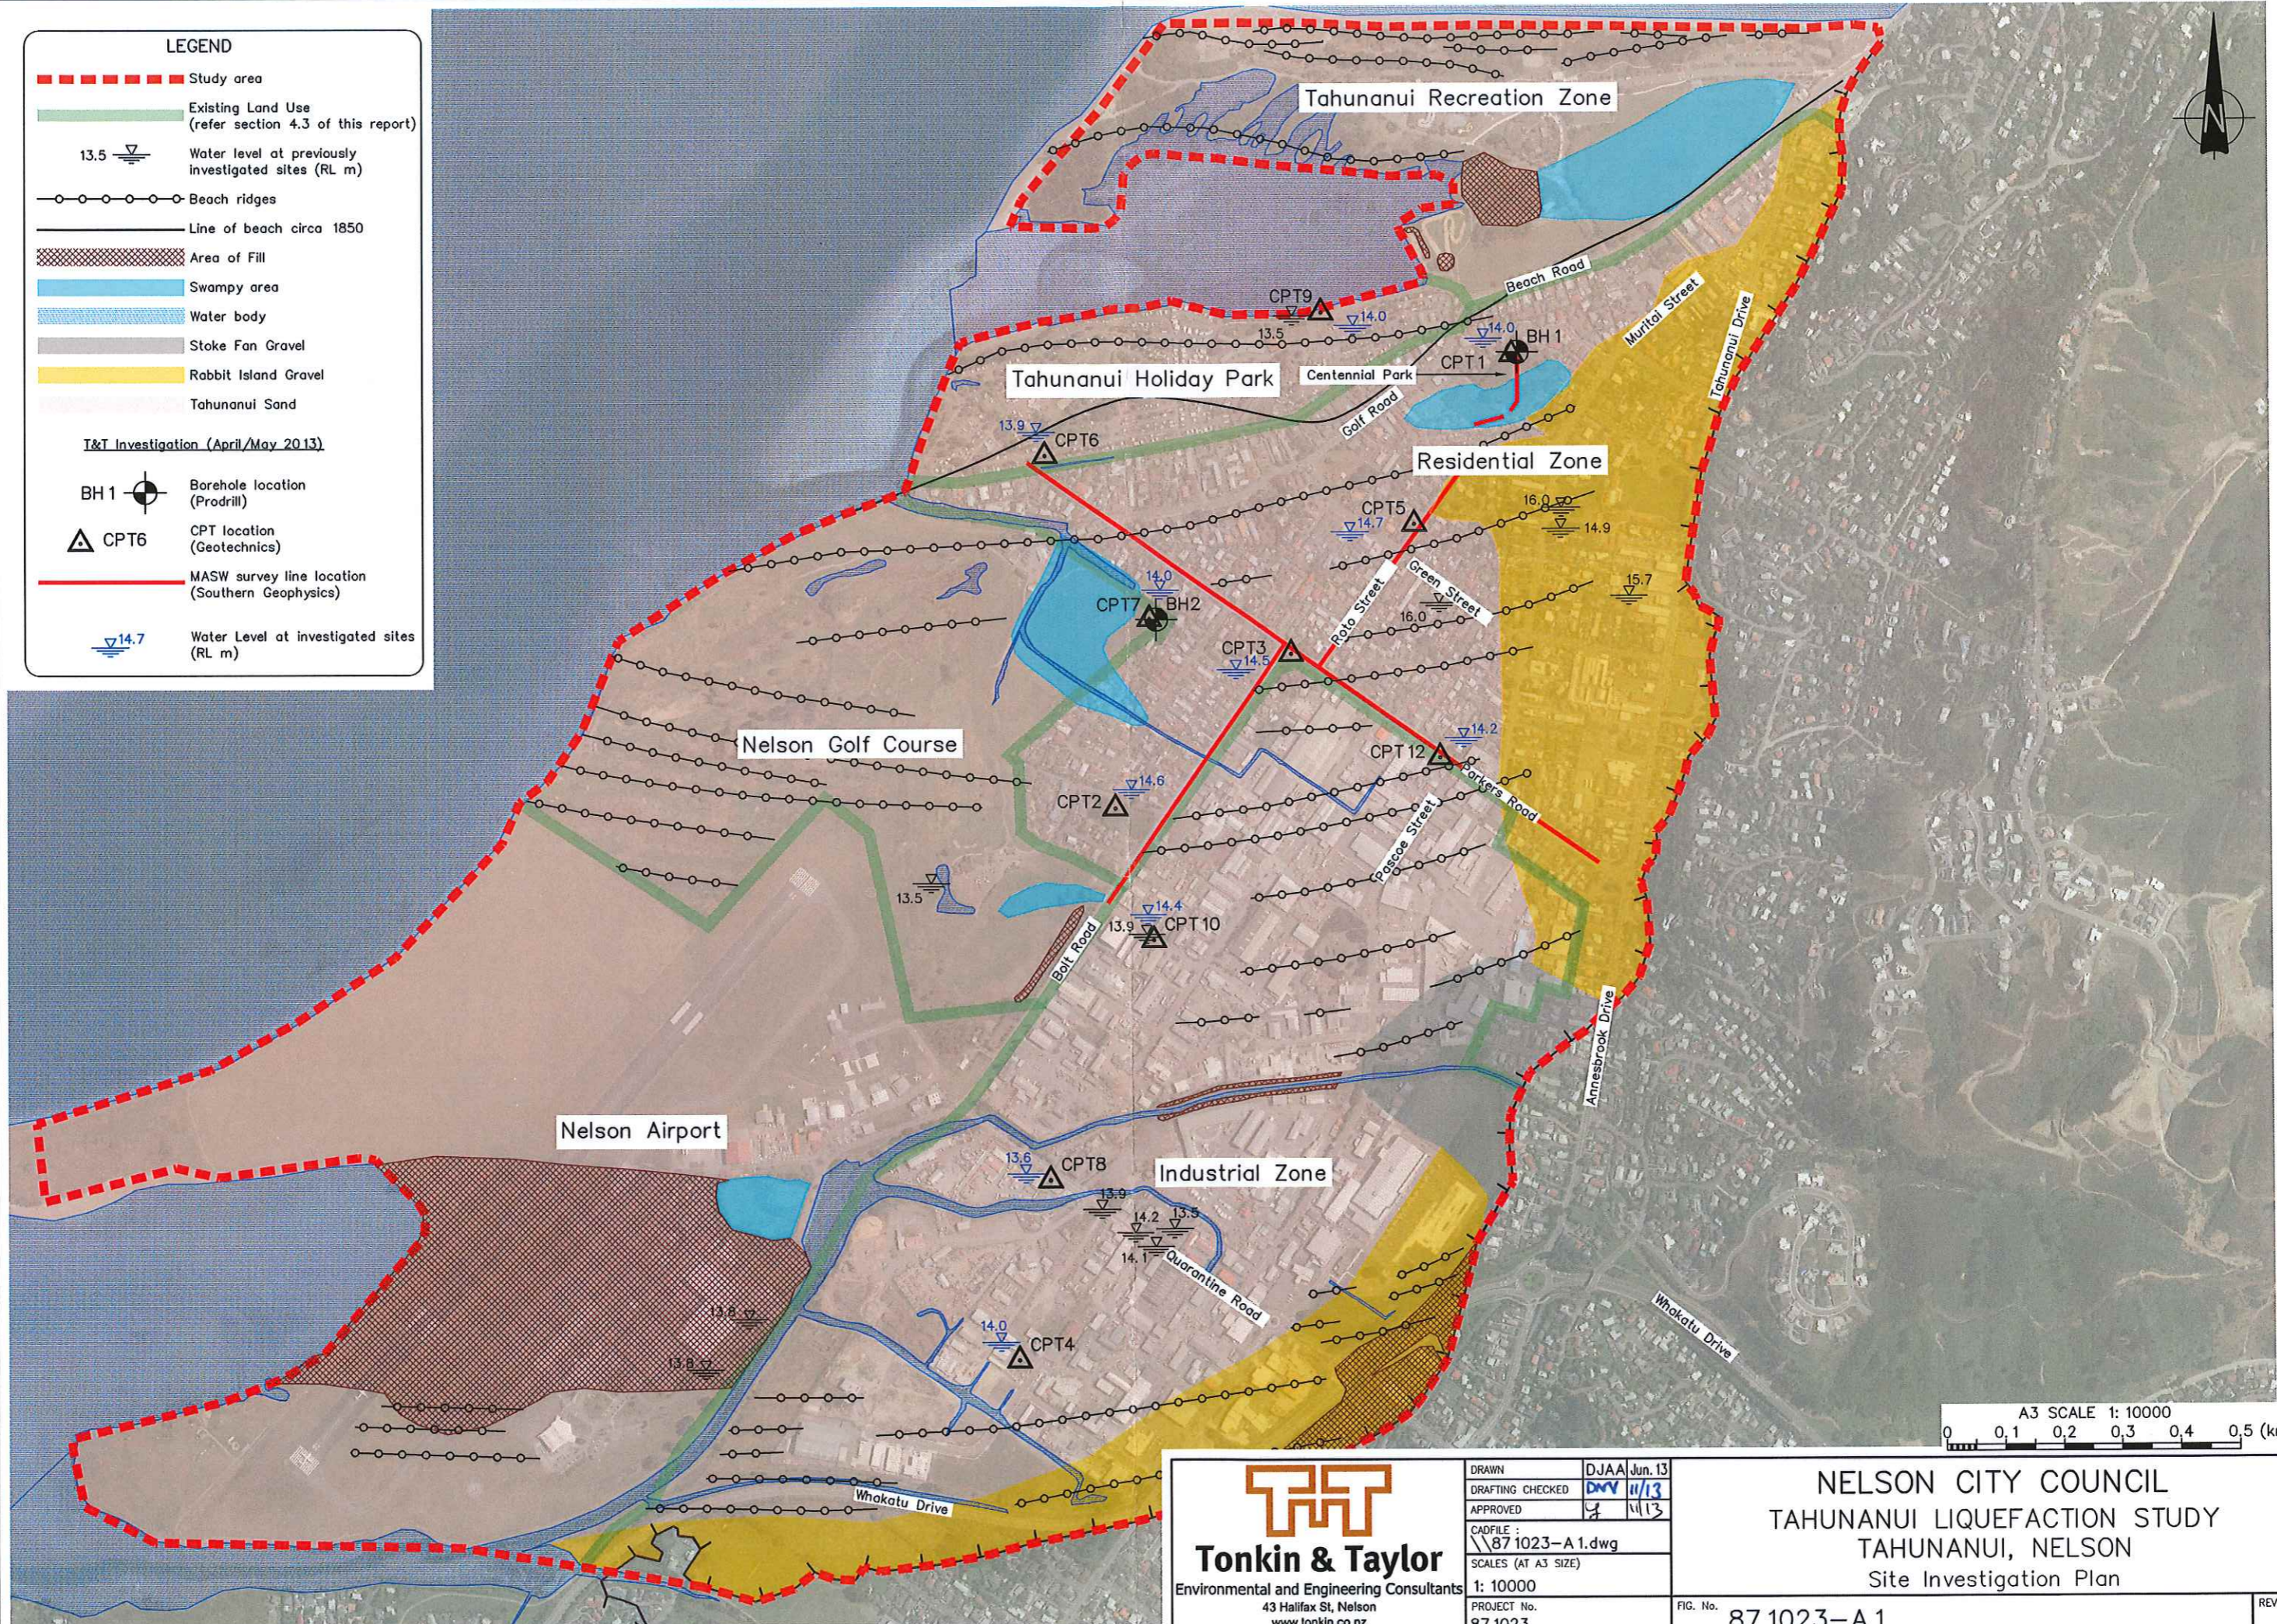
T&T Investigation (April/May 2013)

- ⊕ BH 1 Borehole location (Prodrill)
- △ CPT 6 CPT location (Geotechnics)
- MASW survey line location (Southern Geophysics)
- $\nabla 14.7$ Water Level at investigated sites (RL m)

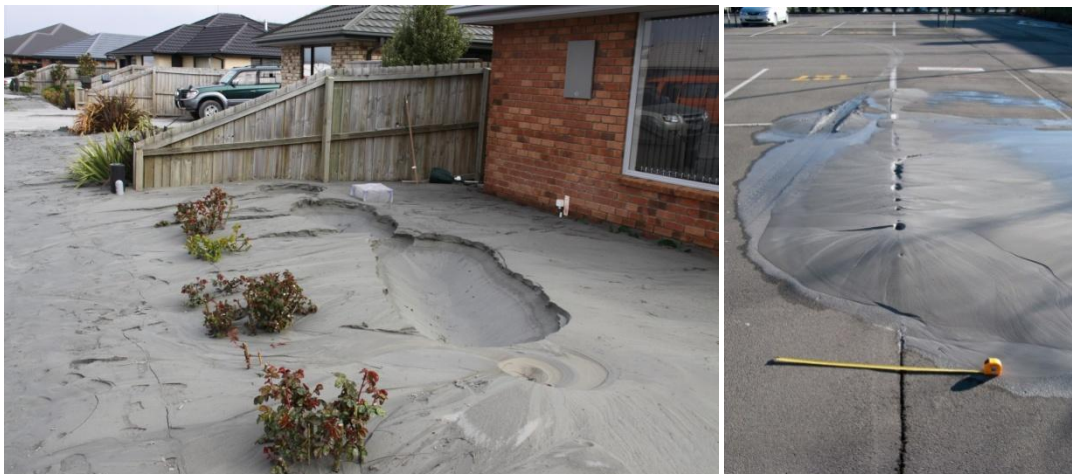
Liquefied soils often release their water pressures to the surface. This is particularly evident where the crust of non-liquefied soil is relatively thin. This can result in water and soil being ejected to the surface. These are observed as “sand boils” or mini-volcanos. This flow of water and soil to the surface can damage floor slabs, pavements and services. Of the effects of liquefaction, sand boils is typically the most damaging to residential developments. It results in; uneven subsidence of the ground surface, and damage to buildings, paved surfaces and infrastructure.

Figure B2: Surface ejection of soil and water as sand boils

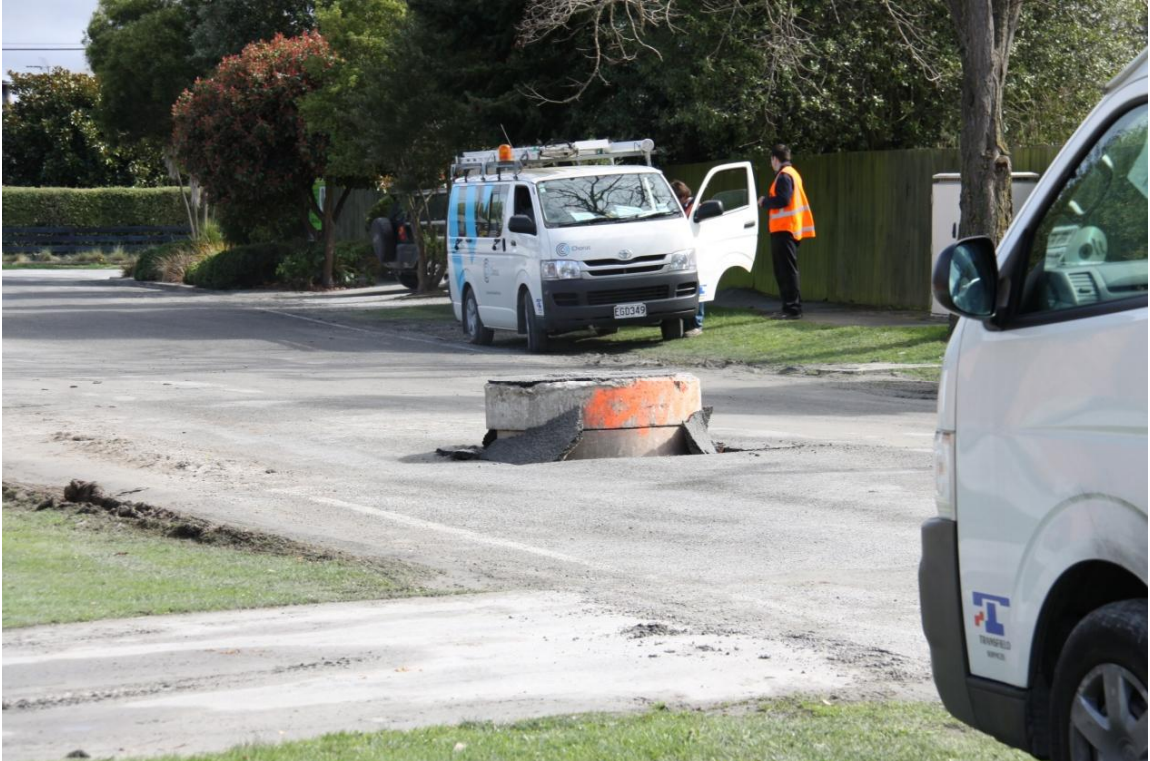
Increased groundwater pressures due to seismic shaking can cause buoyancy forces on structures and services. These forces, along with the reduced strength of liquefied soils can lead to uplift of pipes, manholes, chambers and swimming pools extending below the groundwater level.

Figure B3: Manhole uplifted due to buoyancy

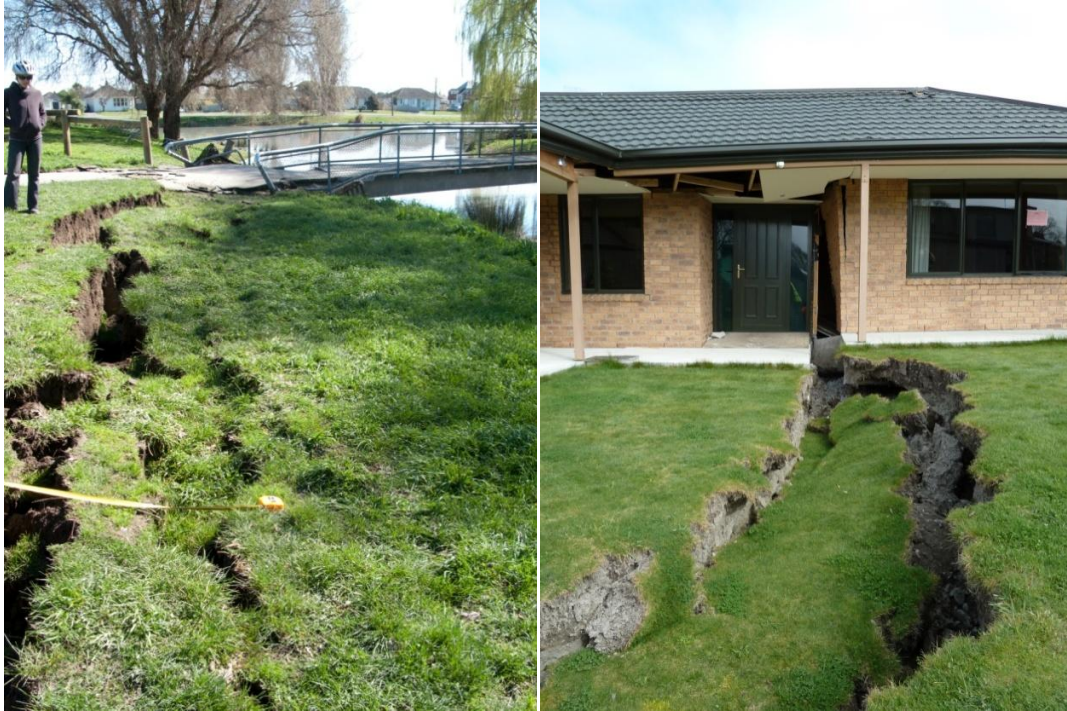
Lateral spreading is the displacement of the ground horizontally with shaking. Associated vertical displacement can also occur. Lateral spreading can occur on sloping or unrestrained ground (ground adjoining a river, foreshore or other free face). It is as a result of ground sliding on a liquefied layer during and possibly after (flow failure) the shaking. Sloping ground only needs to be very gentle for lateral spreading to occur. Lateral spreading in the order of meters can occur immediately adjoining a free face, and can be in the order of tens of millimetres at 100 m distance. However, in Christchurch where there was gently sloping ground back from the free face, displacements of hundreds of millimetres at 100 meters back from the free face were observed.

Figure B4: Lateral spreading showing horizontal and vertical displacement of land causing damage to structures

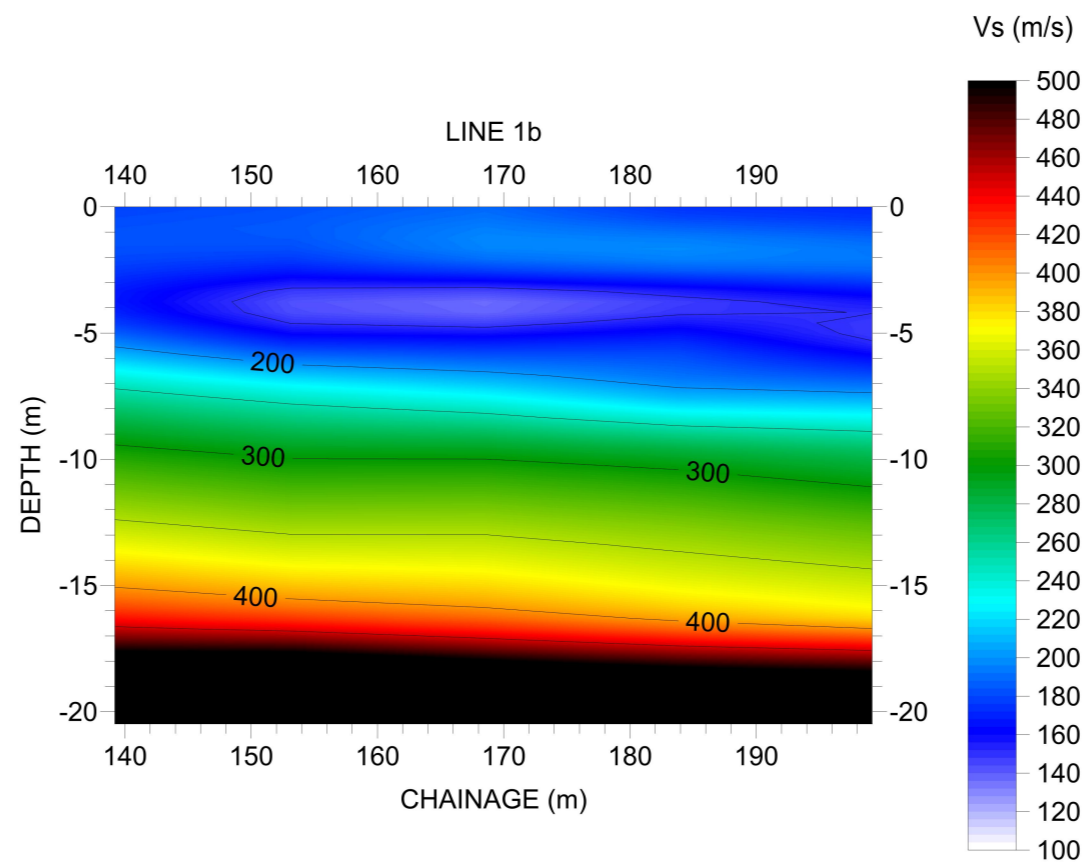
TITLE-	MASW LINE 1b (139.2m - 199.2m)
LOCATION-	Tahuna, Nelson

NOTES
 Contour intervals of 50 m/s (Vs).
 Refer to site map for location.

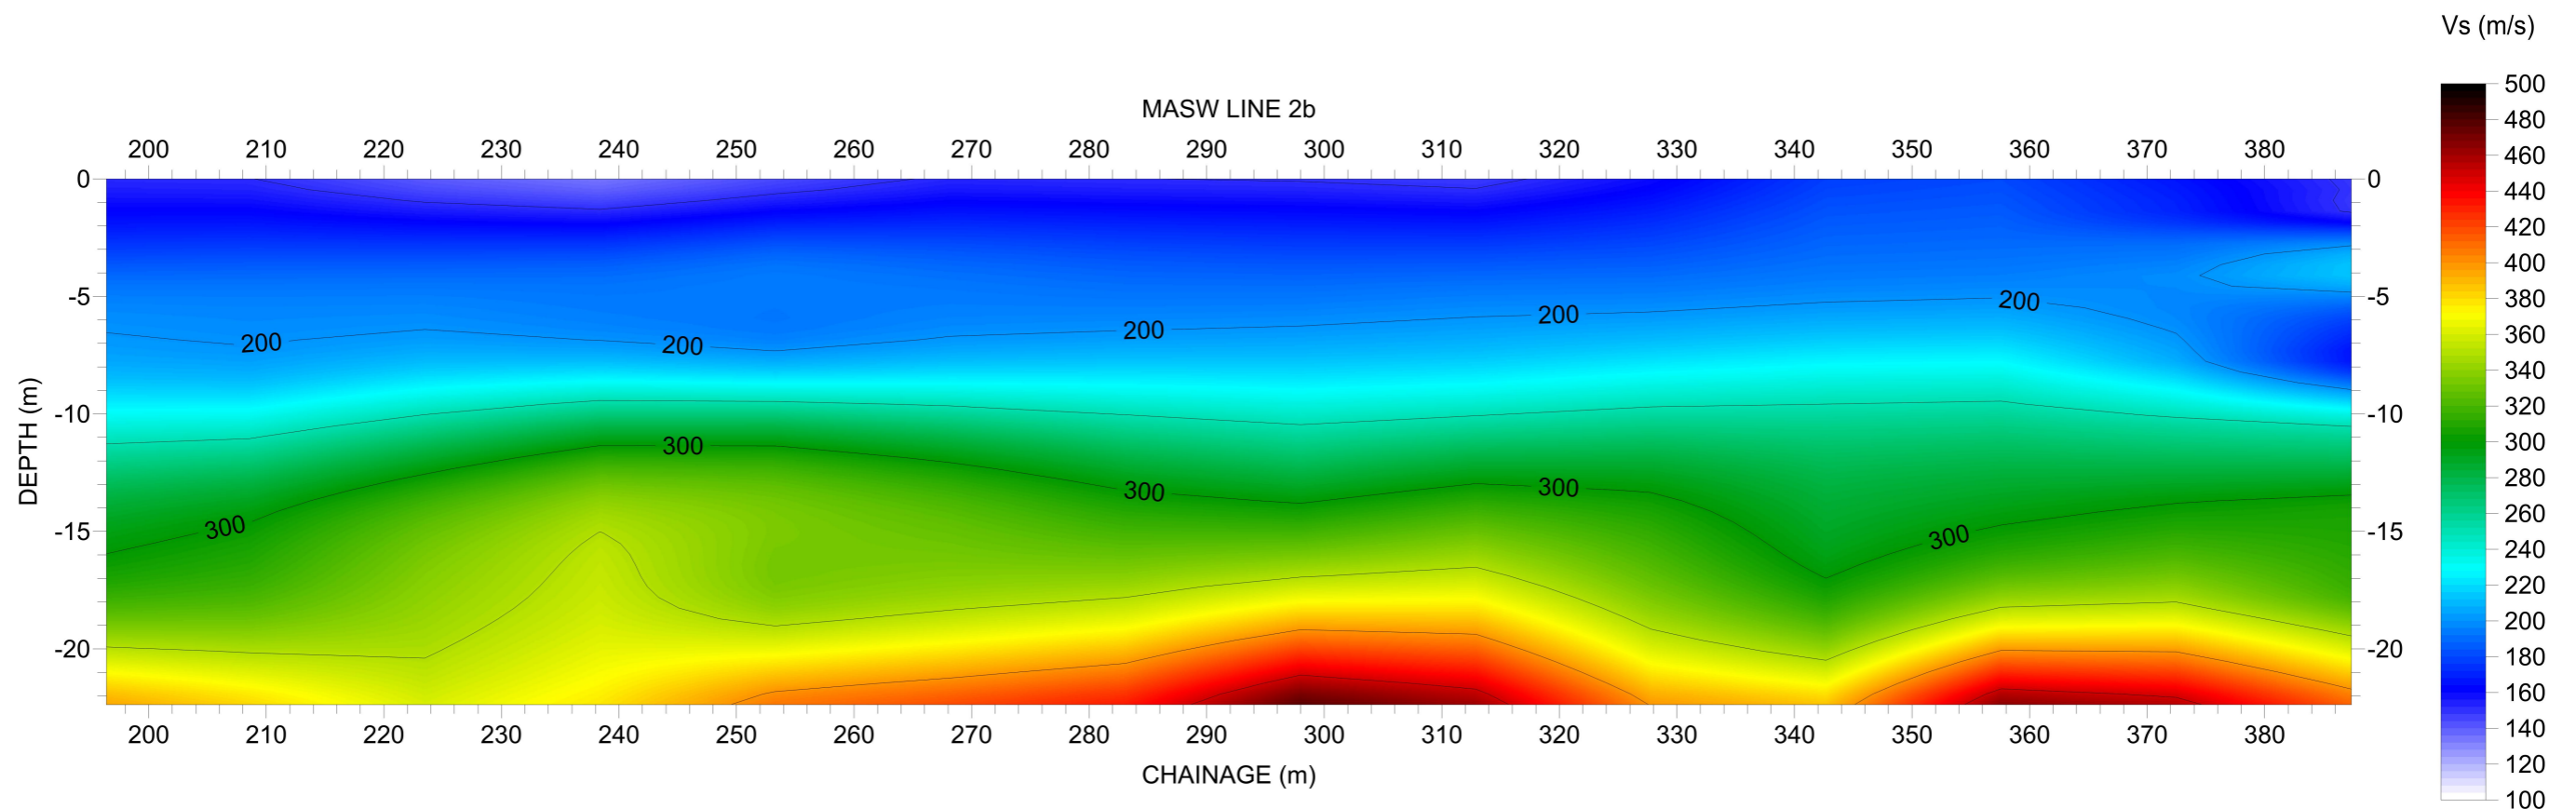
TITLE-	MASW LINE 2b (196.4m - 387.4m)
LOCATION-	Tahuna, Nelson

NOTES
 Contour intervals of 50 m/s (Vs).
 Refer to site map for location.

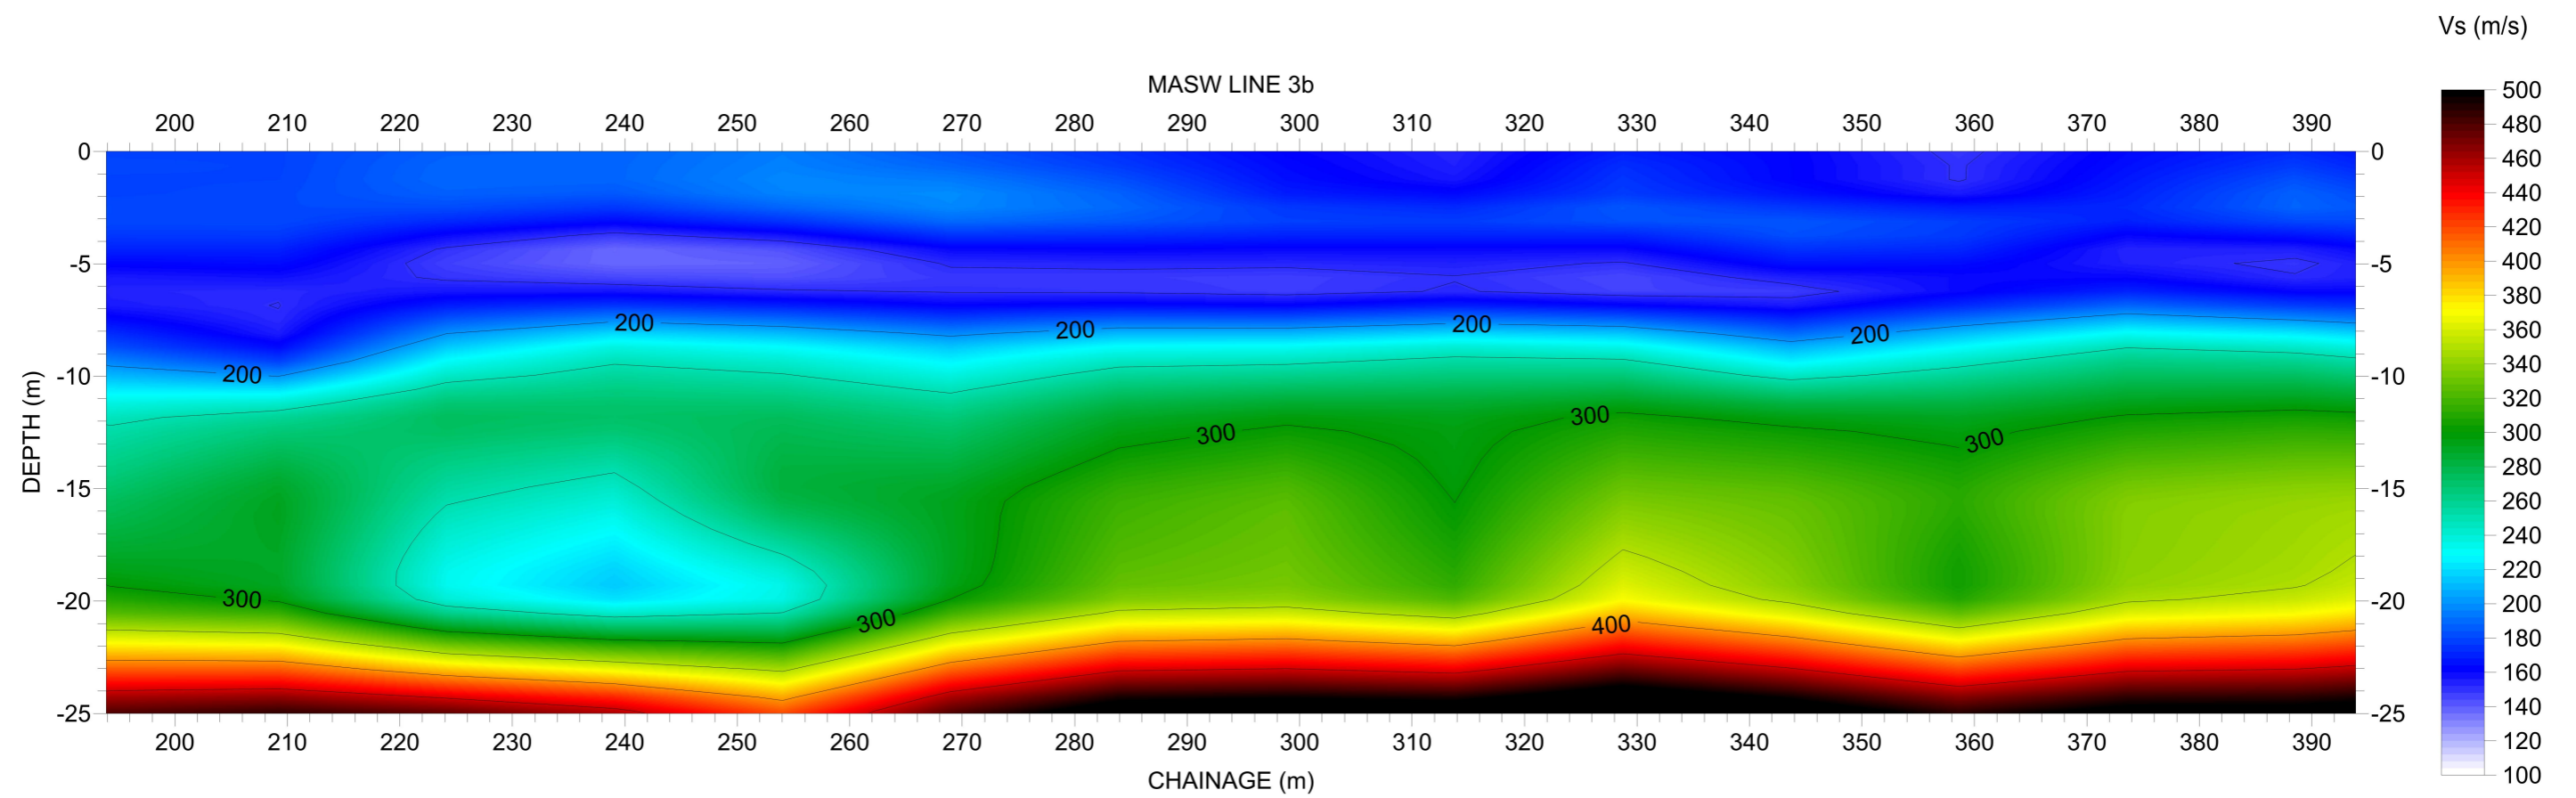
TITLE-	MASW LINE 3b (193.9m - 393.9m)
LOCATION-	Tahuna, Nelson

NOTES
 Contour intervals of 50 m/s (Vs).
 Refer to site map for location.

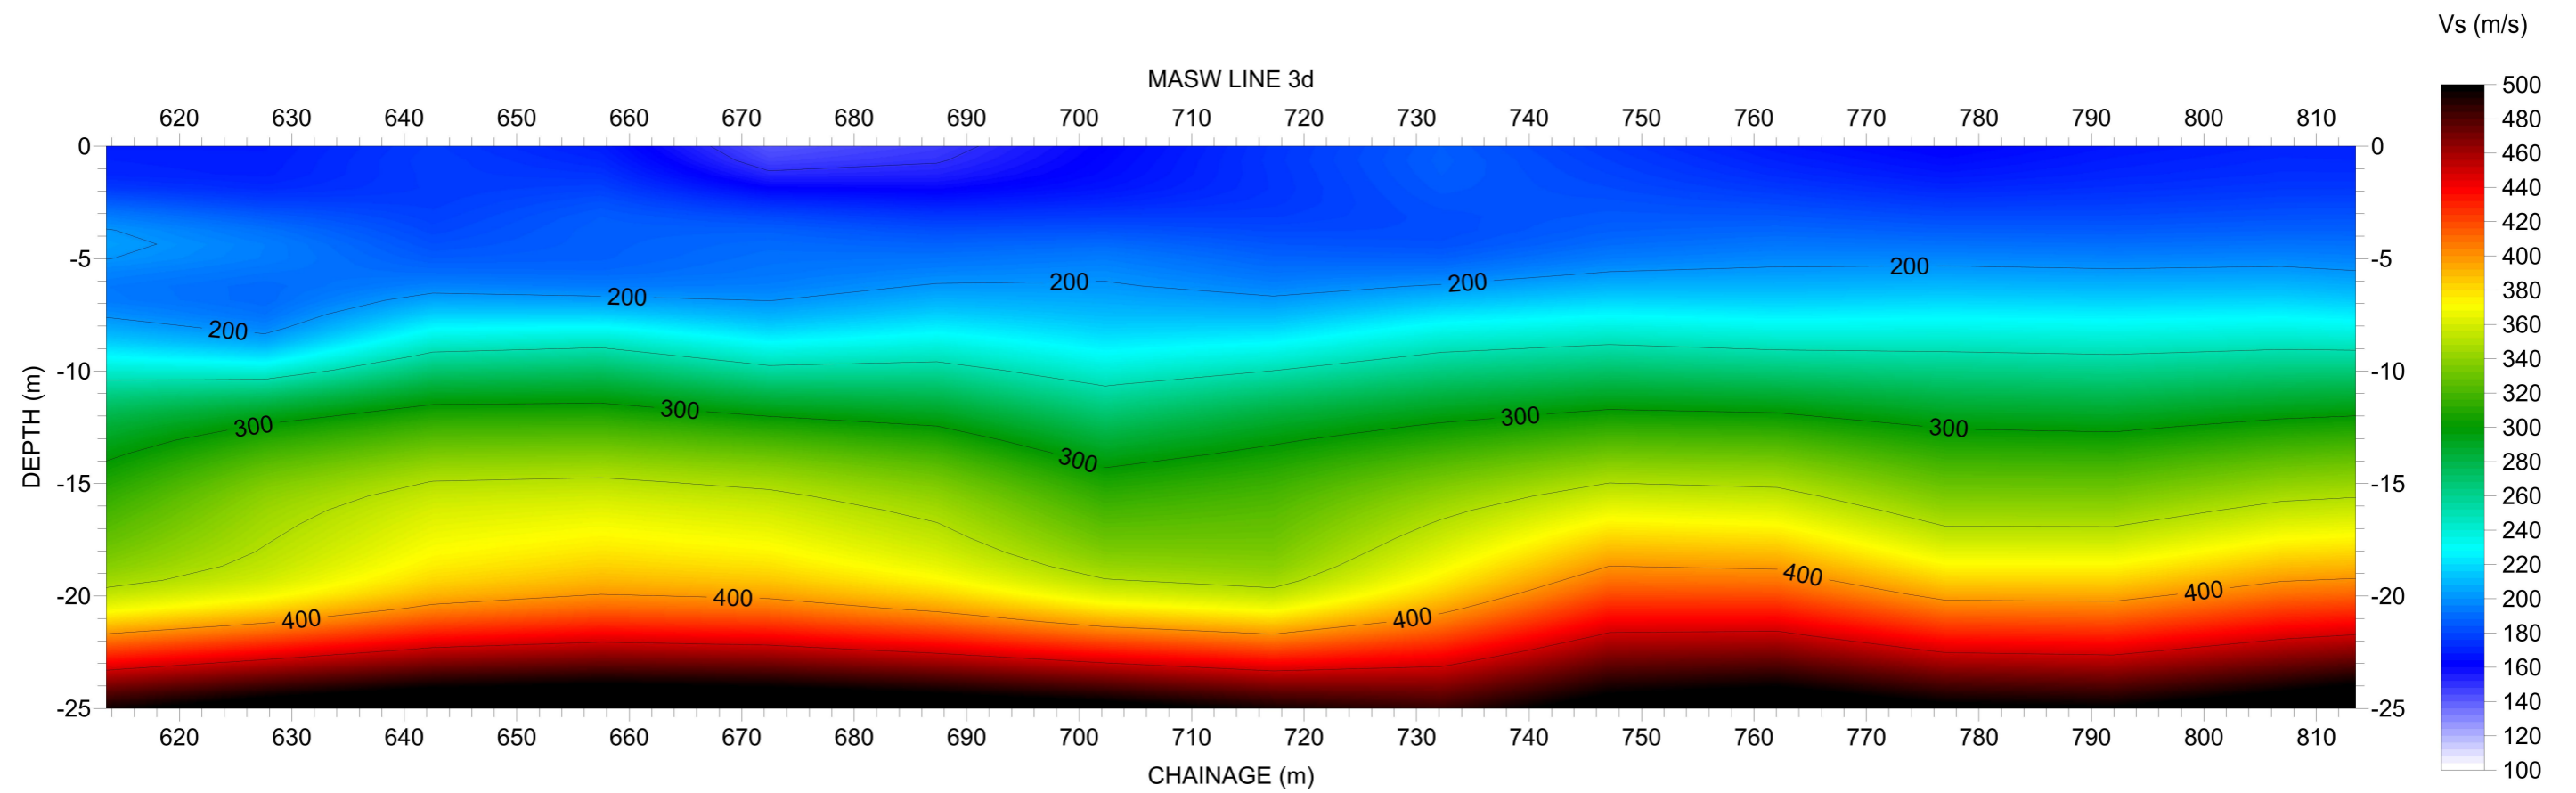
TITLE-	MASW LINE 3d (613.5m - 813.5m)
LOCATION-	Tahuna, Nelson

NOTES
 Contour intervals of 50 m/s (Vs).
 Refer to site map for location.

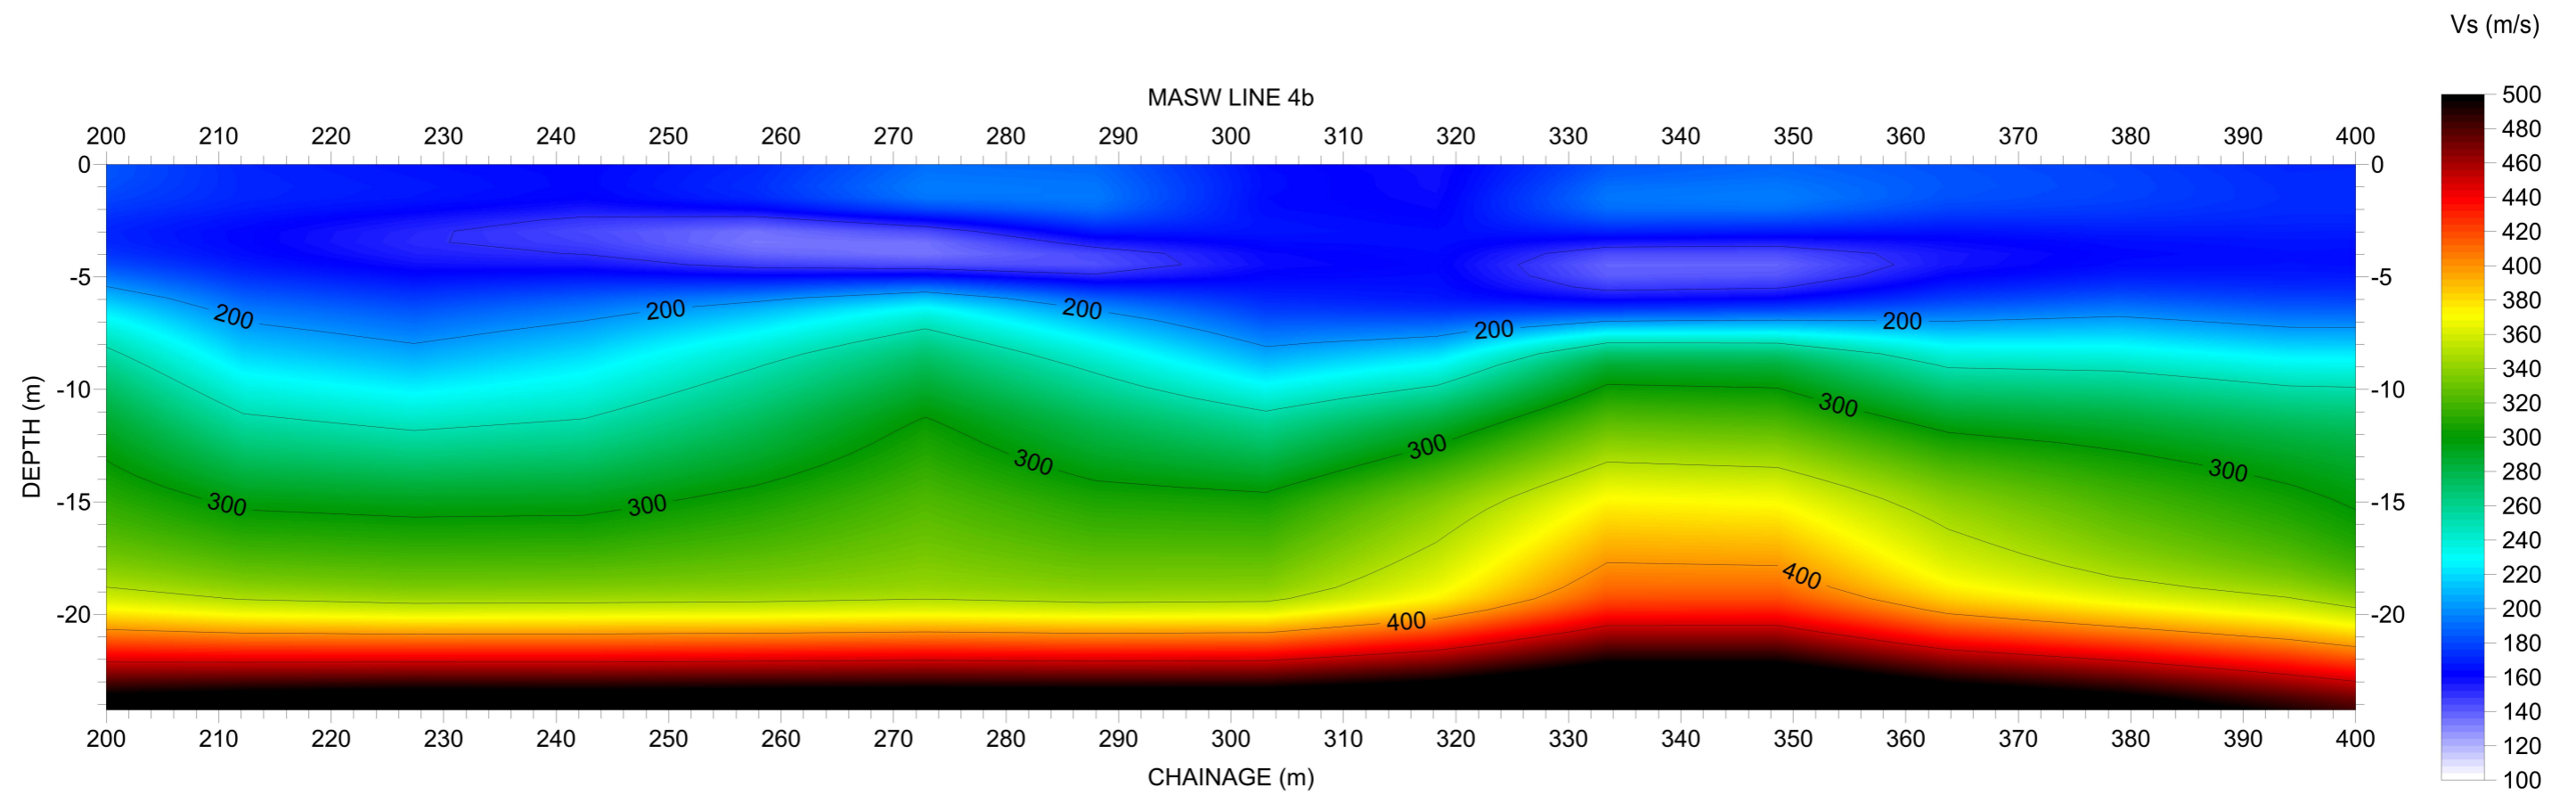
TITLE-	MASW LINE 4b (200m - 400m)
LOCATION-	Tahuna, Nelson

NOTES
 Contour intervals of 50 m/s (Vs).
 Refer to site map for location.
